# QDec Measurement Summary

| <b>Panel:</b> | Helio_AA36 | <b>Meas. Date:</b> | 24.07.2015 - 01:28:39 |

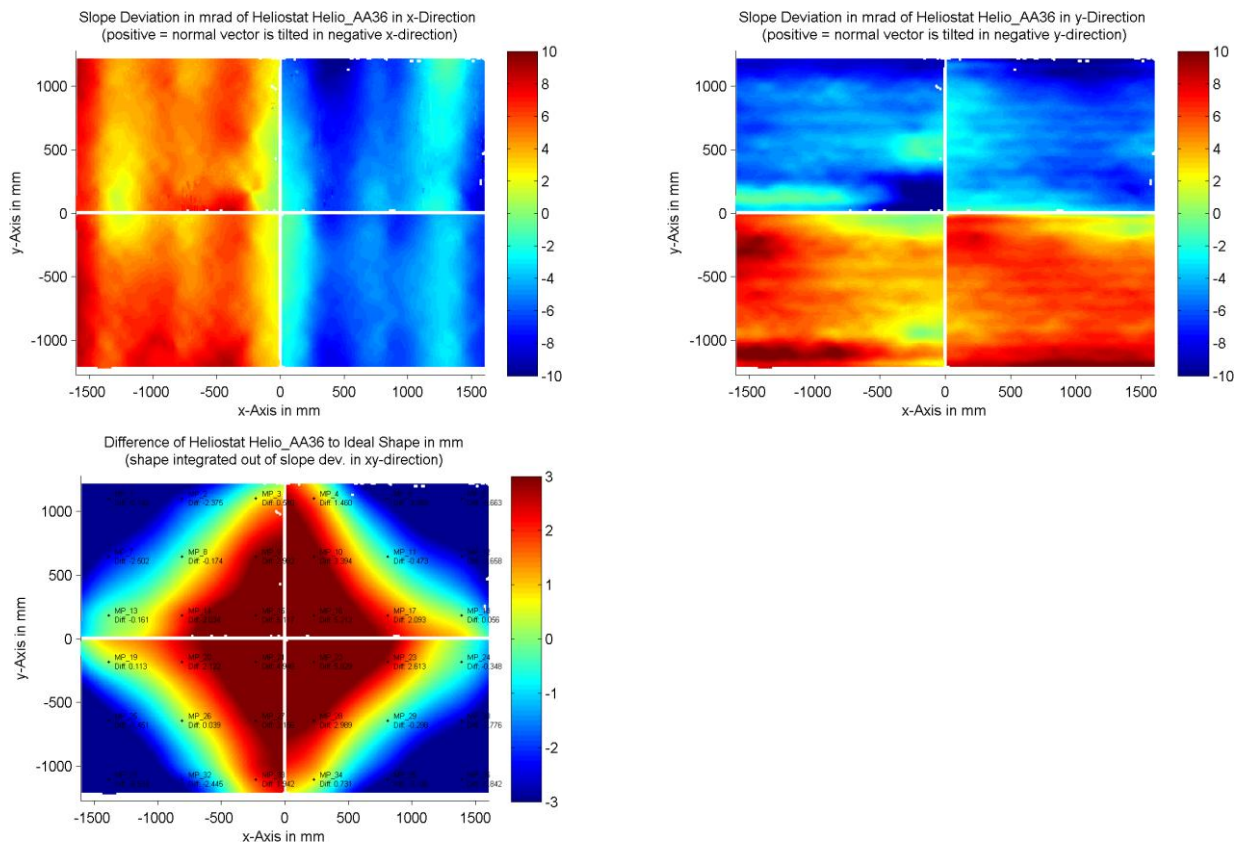
## Result Graphs

**Quality:** no specifications      Evaluated Surface: 95.5 %

| Value | Measurement | Specification | Description |
|---|---|---|---|
| SDx | 5.30 mrad | | Slope deviation in x-direction (rms) |
| SDy | 5.80 mrad | | Slope deviation in y-direction (rms) |
| ICAP_D1 | 99.42 % | | Intercept on aperture |
