# QDec Measurement Summary

| <b>Panel:</b> | Helio_BC62 | <b>Meas. Date:</b> | 06.02.2023 - 18:35:38 |

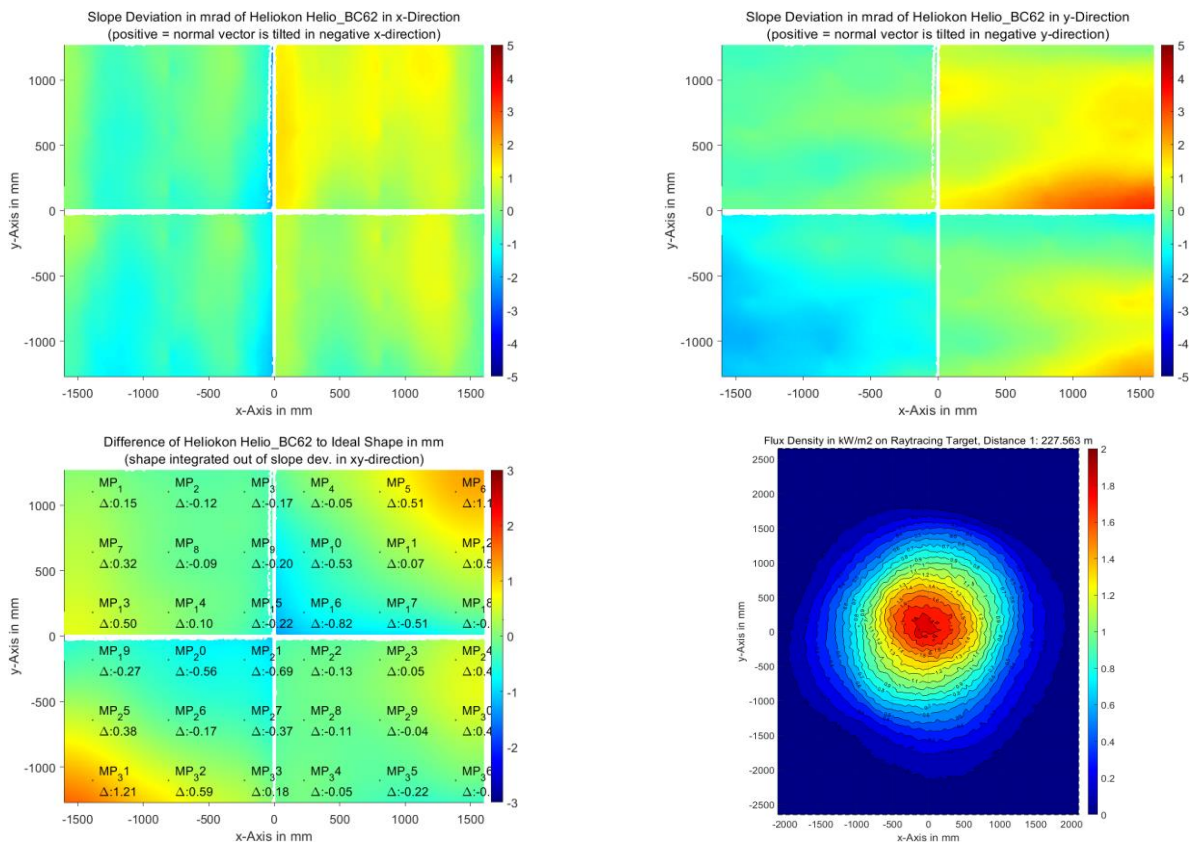
## Result Graphs

| Value | Measurement | Specification | Description |
|---|---|---|---|
| SDx | 0.73 mrad | | Slope deviation in x-direction (rms) |
| SDy | 1.00 mrad | | Slope deviation in y-direction (rms) |
| ICAP_D1 | 97.18 % | | Intercept on aperture |
