# QDec Measurement Summary

<b>Panel:</b>	Helio_BG23	<b>Meas. Date:</b>	11.05.2016 - 00:13:52
<b>Paneltype:</b>	Heliostat	<b>Operator:</b>	DLR Expert User
<b>Setup:</b>	MeasPosition	<b>Comment:</b>	
<b>Negl. Rim:</b>	0 mm	<b>System:</b>	QDec_2014-101
<b>Orientation:</b>	Mean Slope to Zero	<b>Location:</b>	Jülich

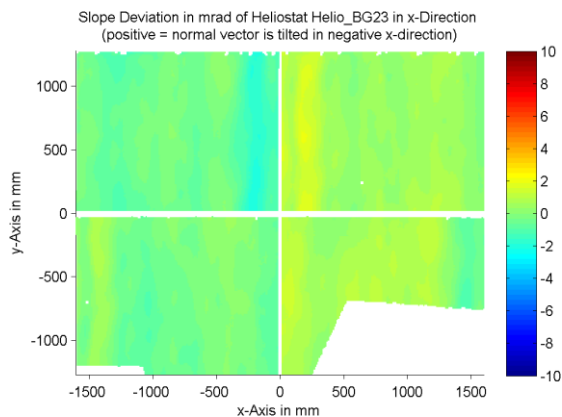
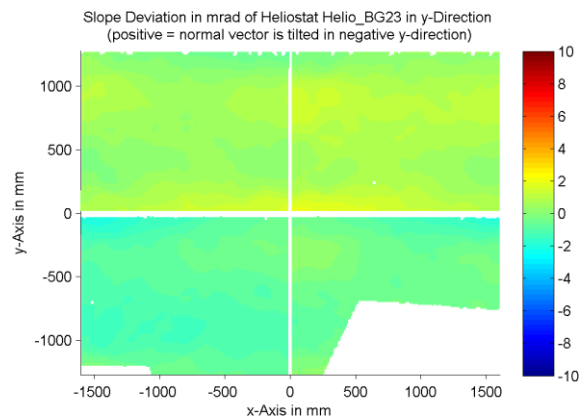
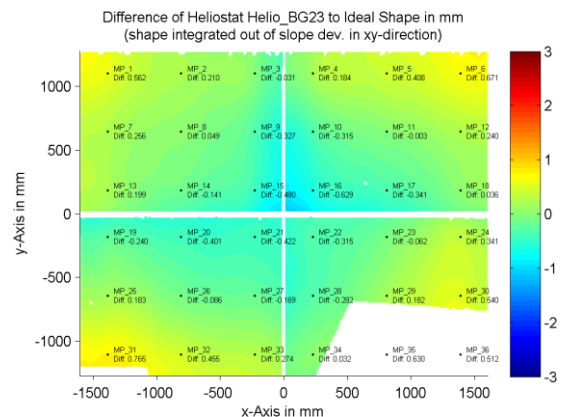
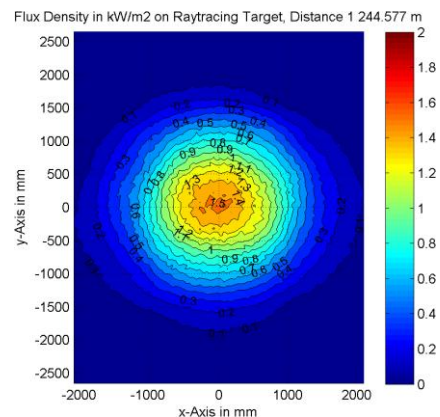
## Result Graphs

**Quality:** no specifications      Evaluated Surface: 90.6 %

Value	Measurement	Specification	Description
SDx	0.67 mrad		Slope deviation in x-direction (rms)
SDy	0.79 mrad		Slope deviation in y-direction (rms)
ICAP_D1	96.72 %		Intercept on aperture
