# QDec Measurement Summary

| <b>Panel:</b> | Helio_BM37 | <b>Meas. Date:</b> | 05.10.2016 - 20:18:26 |

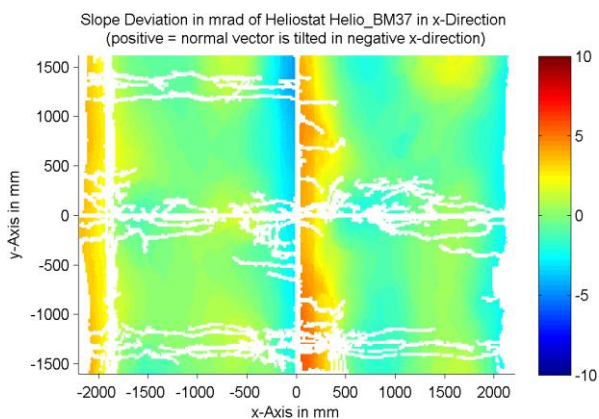
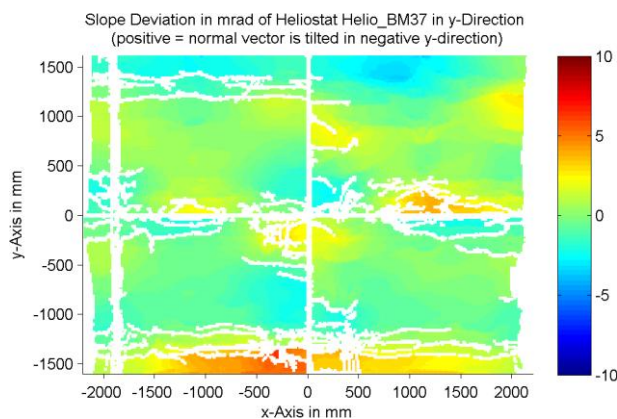
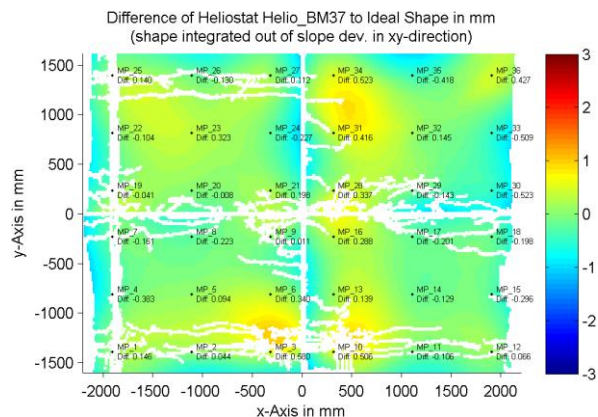
## Result Graphs

**Quality:** no specifications      Evaluated Surface: 86.2 %

| Value | Measurement | Specification | Description |
|---|---|---|---|
| SDx | 1.57 mrad | | Slope deviation in x-direction (rms) |
| SDy | 1.46 mrad | | Slope deviation in y-direction (rms) |
| ICAP_D1 | 86.57 % | | Intercept on aperture |
